**PRELIMINARY INVESTIGATION REPORT INTO
SHOSHOLOZA MEYL LEVEL CROSSING COLLISION AT
GENEVA STATION BETWEEN HENNEMAN AND
KROONSTAD**

OPERATOR	PRASA
PERMIT NUMBER	ASP0002NTS
INVESTIGATION SUBJECT	PRASA Rail level crossing collision at Kroonstad in the Free State
DATE OF OCCURRENCE	04 January 2018
REFERENCE NUMBER	RSR/20180104/002

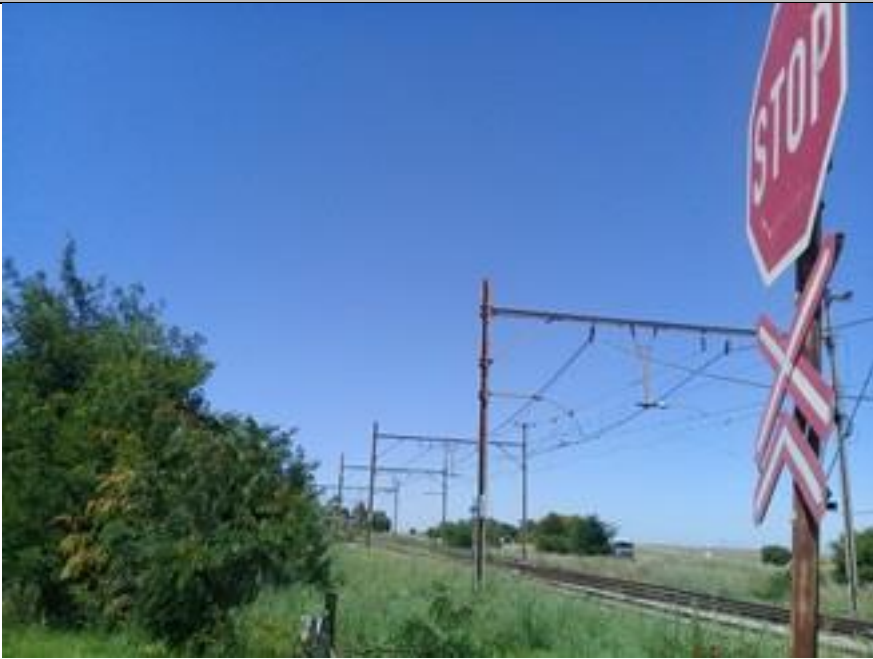
The line of sight at the level crossing
P5

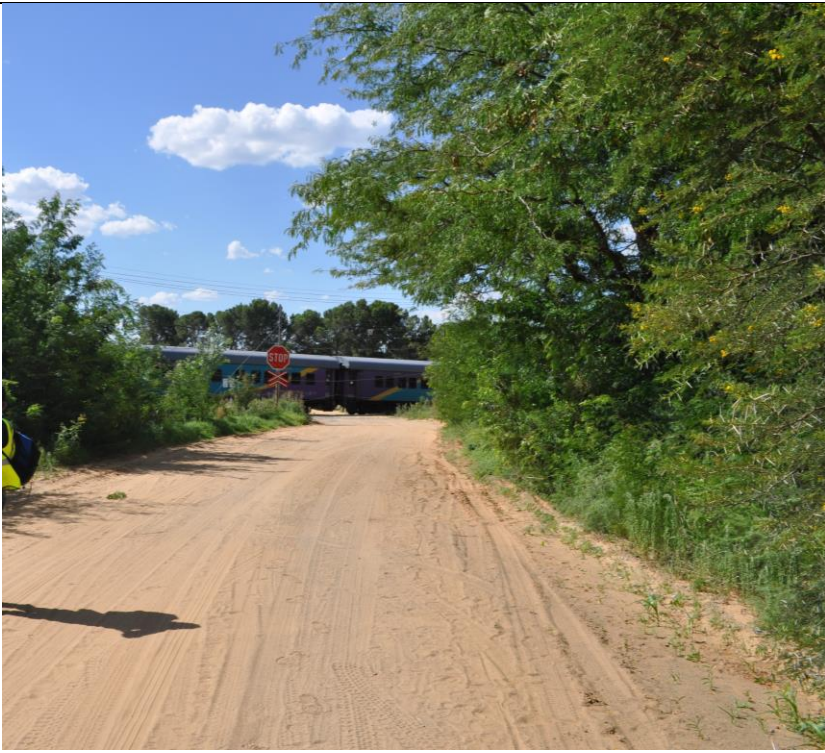
- 5.2 As indicated in the pictures below, some shrubs are noticeable along the eastern approach to the level crossing (See P3, P5 and P7). However, it was established that the rail line is visible from the stop sign.

Trees along the level crossing approach

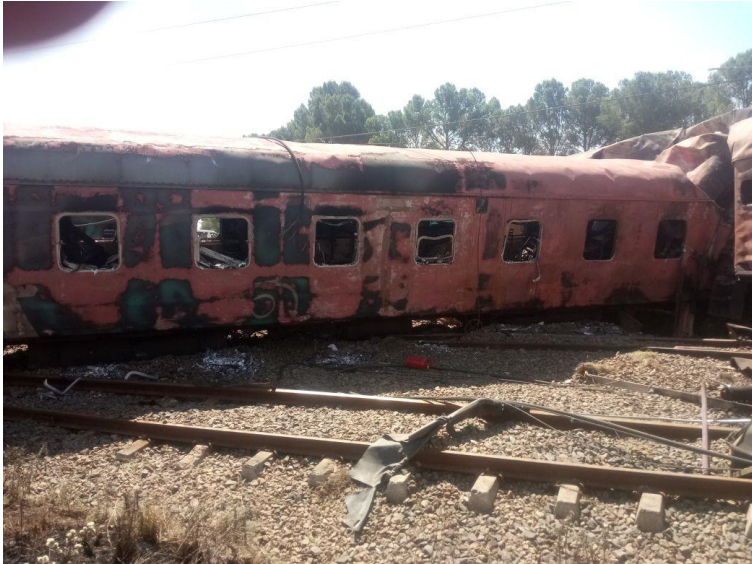
- h) 36-010
 - i) 36-274
 - j) 36-203
 - k) 104
- 5.10 Five of the aforementioned derailed coaches caught fire and burnt. Arcing marks were noticeable on the roof of some of the carriages. Numbers of the affected rolling stock are as follows:

<p>Coaches that derailed, caught fire and burnt</p>
P10

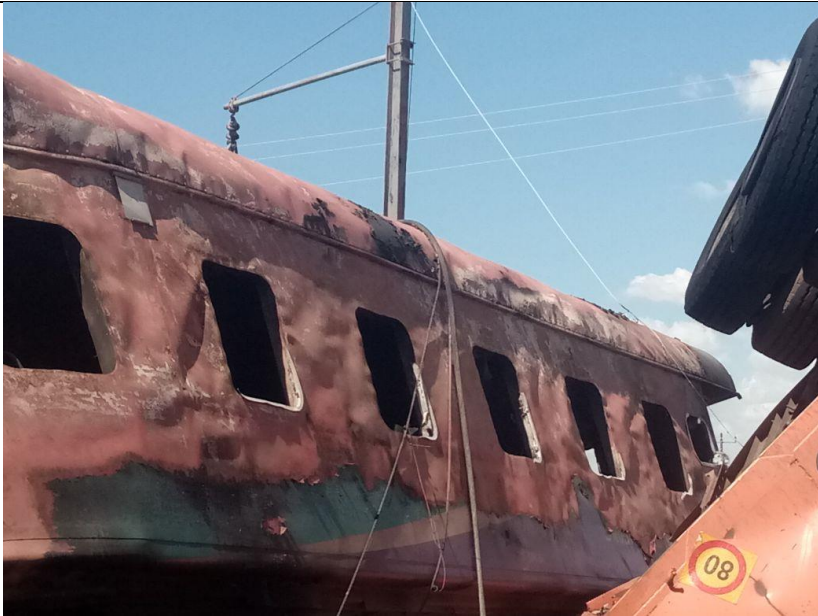
- 5.8 The railway infrastructure was also seriously damaged including the track and catenary wires. The overhead wire snapped and fell on top of the coaches after the occurrence. Arcing were noticeable on the roofs of the burnt coaches.

<p>The overhead line on top of the coach that caught fire. The overhead line snapped and fell on top of the coaches after the occurrence.</p>
