## Report by the Minister of Police to Parliament on security upgrades at the Nkandla private residence of the President

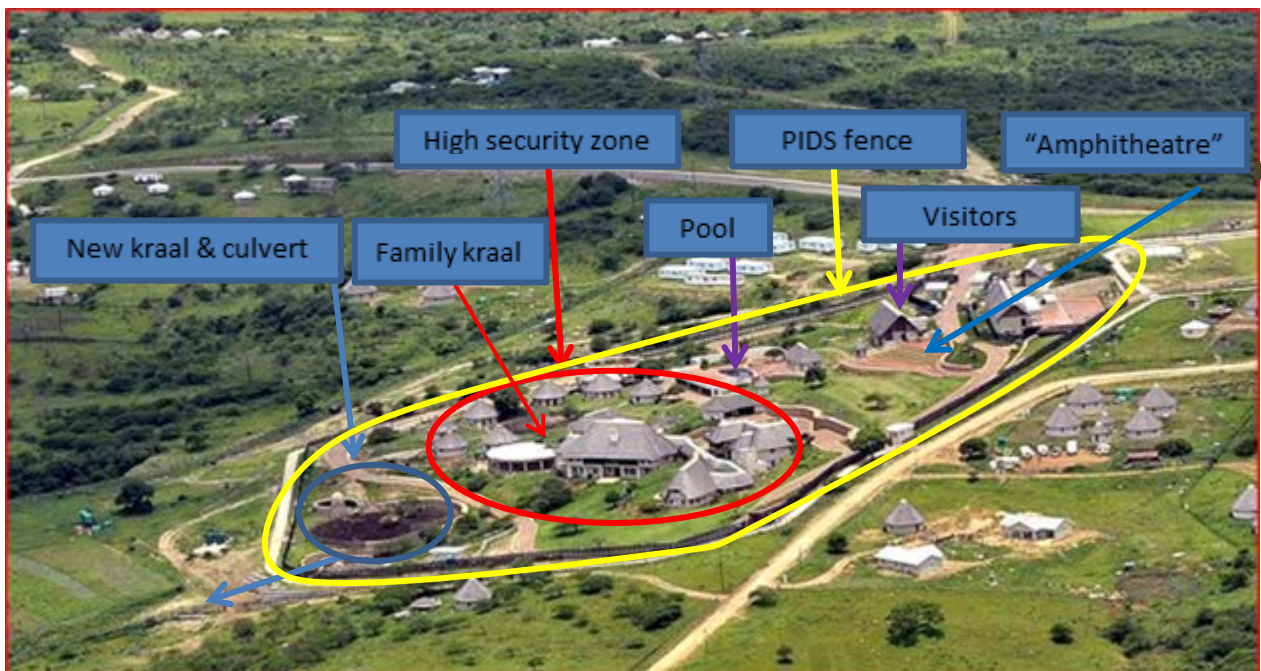
**Figure 1: The aerial picture of the Nkandla Homestead**

*The black steel fence around the homestead is the outer Perimeter PIDS fence. Below the inner lower road are the new kraals with culvert and chicken run. All houses below the swimming pool and lower road are located in the high security zone. The high security zone would be protected by Motion Detection Beams*

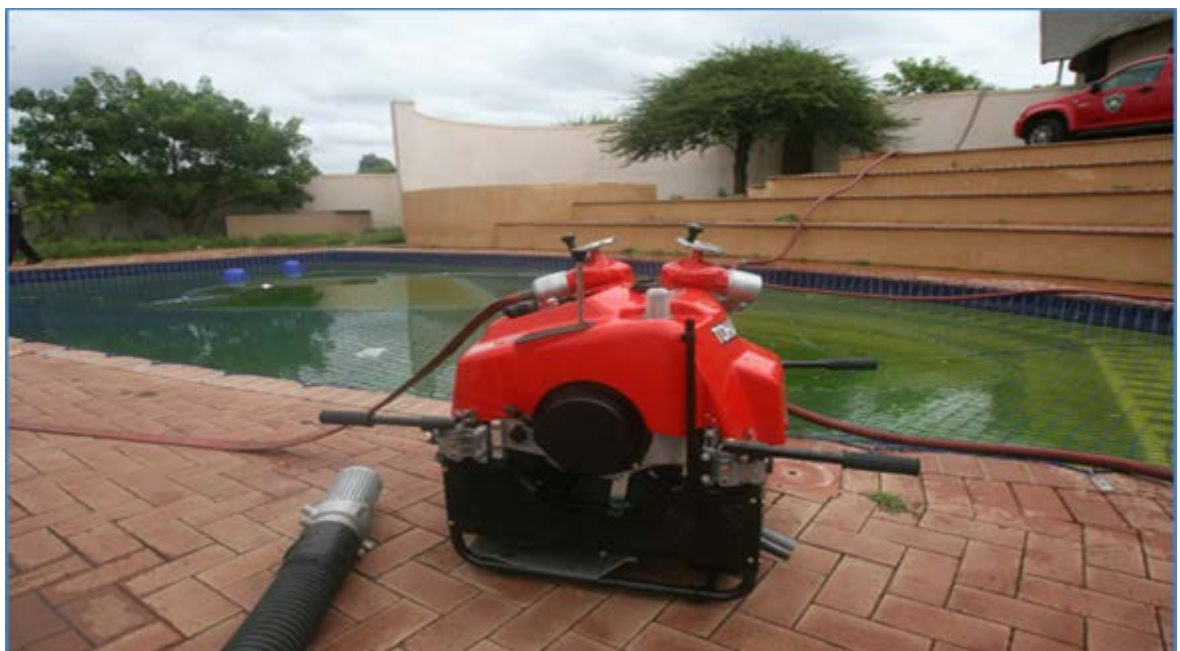
**Figure 2: Fire pool/ swimming pool use for fire fighting**

6.2.4 The pictures below illustrate how the fire pool and/or swimming pool is operated during fire fighting.

- 6.2.5 In terms of the 'Durban Prestige Project A: Motivations and cost allocation summary' dated 25 January 2011, the fire pool "... is a ground water storage facility intended for dual purpose first to be used for fire fighting in the case of emergency. The second use is recreational within the homestead, Note: open surface water compared with reservoir storage is easily accessed in case of emergency...".

- 6.2.6 To provide onsite complementary firefighting equipment the suction pump with 1500L a minute capacity and monitors with 16 centimeter diameter hose, 50 meters long is permanently attached to the pool, for any fire emergency. This capacity is useful to extinguish fire while the fire truck is on the way. It can also refill the fire truck during firefighting operation.

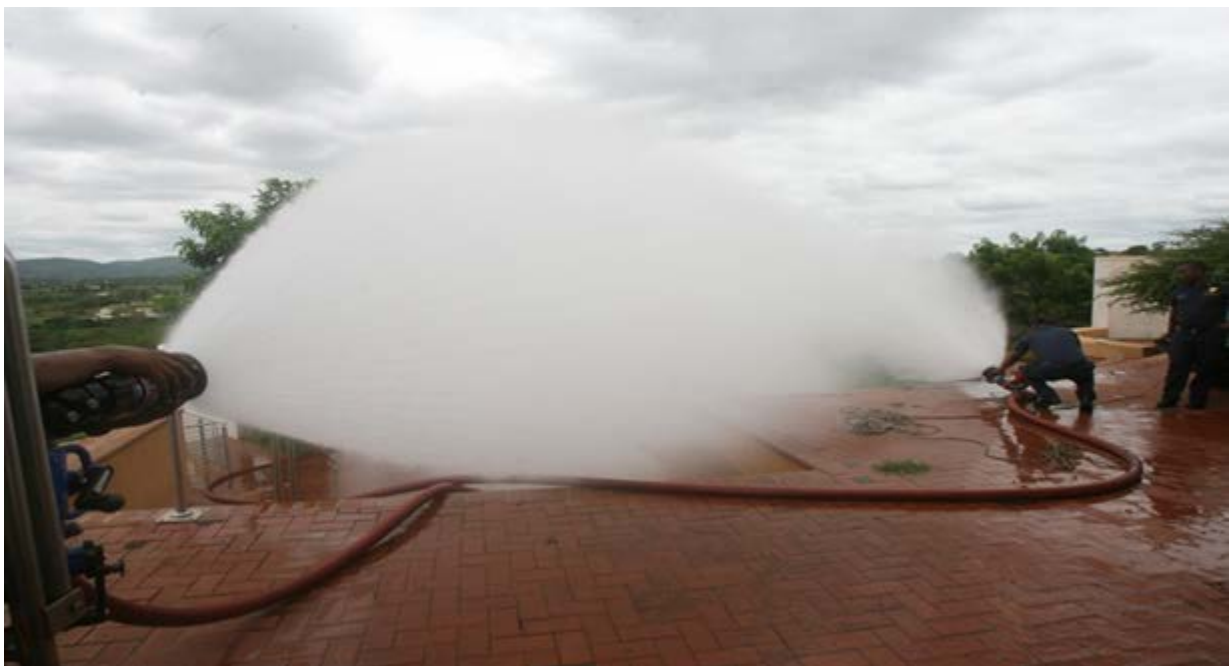
**Figure 3: Firefighting demonstration**

6.2.14 The fire expert concluded, as per the attached Annexure, that the best water source that is available on site at Nkandla is the pool to replenish the fire engine. The pool is equally to be used when the fire breaks out, by deploying the suction pump, linking it with monitors through fire hoses, in order to extinguish fire while the fire truck is on its way. This process is illustrated in the picture below.

6.2.15 The two fire hydrants at the private residence of the President in Nkandla and eight reel fire hoses that are installed there have either very low pressure or no water at all. It should be noted that the water supply to Nkandla by uThungulu District Municipality is erratic, has low pressure and at times runs out. [\(Video firefighting\)](#)

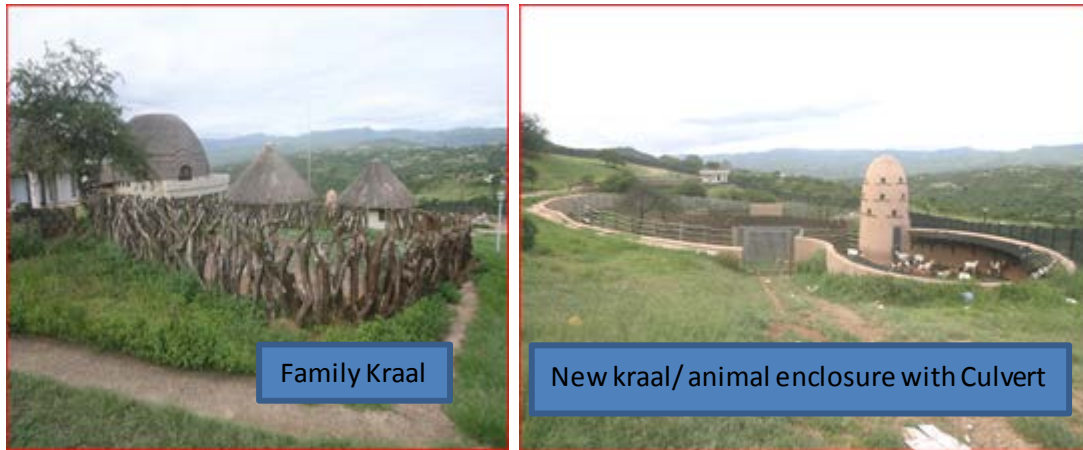
**Figure 4: Family kraal and animal enclosure**

6.3.1 The construction of a kraal and/or animal enclosure was regarded as a non-security feature by the Public Protector. The construction of the kraal and/or animal enclosure and the relocation of the animals is amongst others, discussed in the context of access control and Perimeter Intrusion Detection (PID) Fence Technology Management.

The SAPS Security Evaluation Report states that entrances to the homestead should be controlled and that security equipment and infrastructure should be installed in those entrances. Operational effectiveness of such security equipment and infrastructure necessitated none interference.

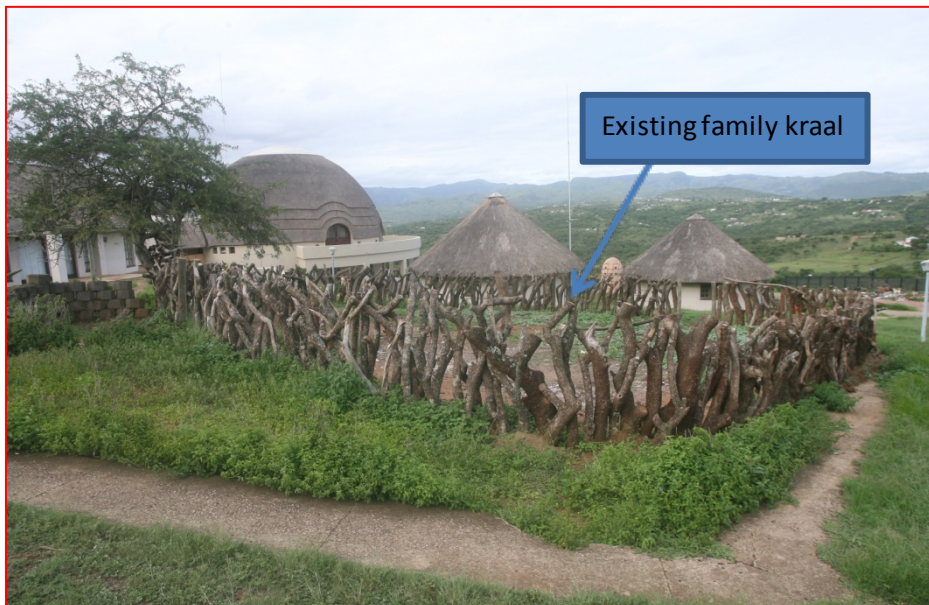
**Figure 5: Existing family kraal**

6.3.2.1 The President's residence has a kraal that the family built, which is at the centre of the homestead. The kraal has significant spiritual and cultural value that extends beyond the storage of animals. Essentially a kraal in its traditional sense is a spiritual and sacred place of a homestead as stated in the paragraph above. [\(Kraal interview\)](#)

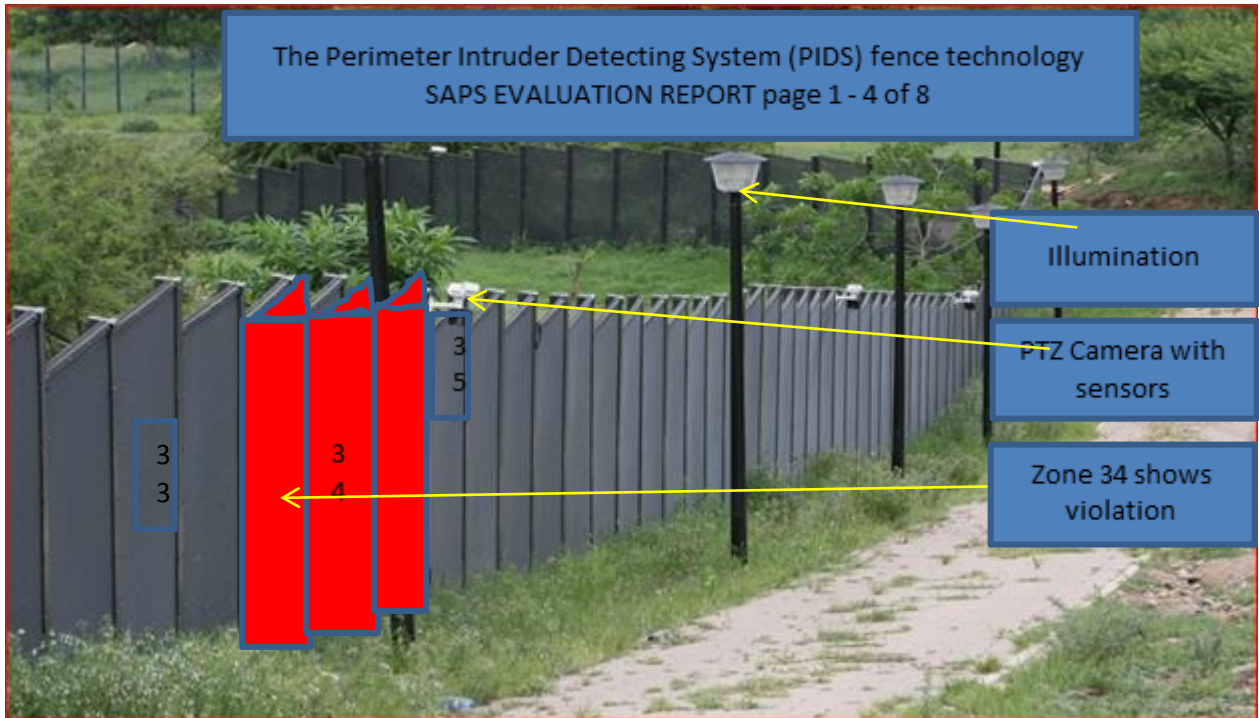
**Figure 6: Perimeter Intruder Detecting System**

6.3.2.2 The SAPS Security Evaluation Report on page 1 of 11 discusses perimeter protection and entrance gates with regard to perimeter protection. The security appraisal states that amongst others; there should be a brick and mortar wall erected and fitted with a six strand electric fence. The electric fence must be divided into zones and be interfaced with the proposed intruder

alarm system as well as the CCTV camera system with analytics. The fence must have passive infra-red motion detectors placed strategically along the fence in sensitive areas (SAPS Evaluation Report, page 4 para 10).

6.3.2.3 Since the family kraal was/ or is located in the high security zone, the continuous use of the family kraal would interfere with the security motion detectors. It was recommended that the animals be relocated to the periphery of the homestead and outside the inner high security zone and within the outer perimeter security fence.

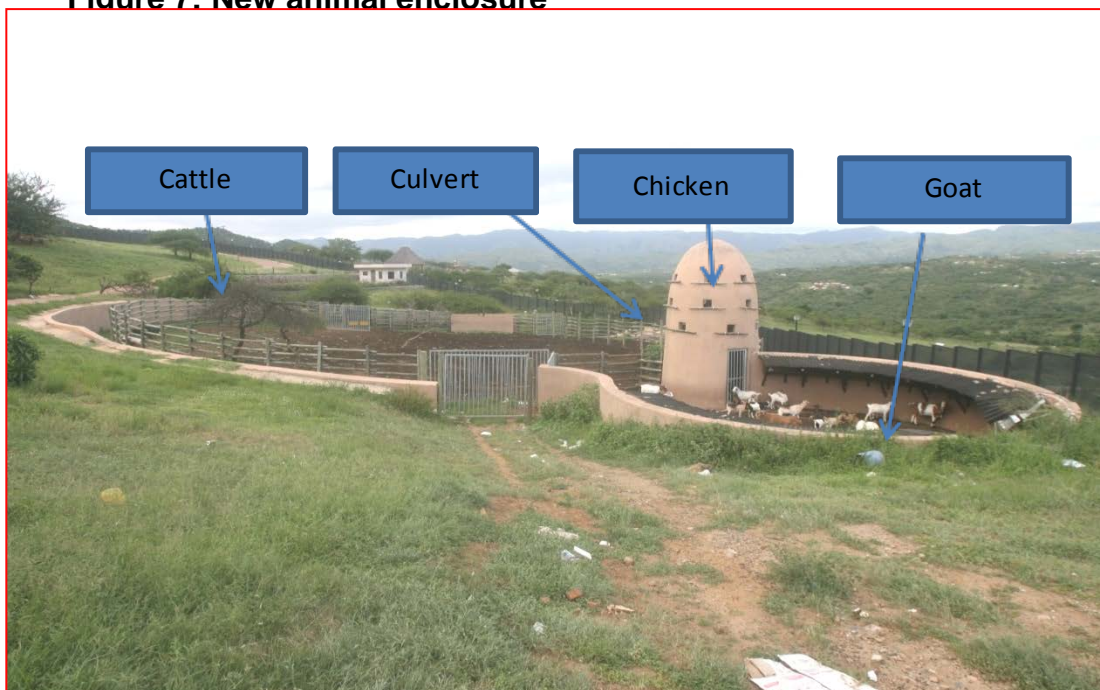
**Figure 7: New animal enclosure**

6.3.3.2 The new animal enclosure with culvert and chicken run was constructed in a remote location away from the high security zone or inner perimeter infrastructure so as to give effect to the fence technology and use thereof. The R&G Consultancy Report, page 28 par 9.6 states that *“the position of the kraal has been influenced by the new security line, culvert and internal security access road ...”*

6.3.3.3 The new animal enclosure complies with the security requirement that animals should be kept outside the high security zone and have an outlet, or culvert, that allows no interface between the livestock and the security infrastructure. The security infrastructure that should not interface with animals include the outer perimeter automated intrusion detecting fence and inner perimeter motion detecting beams as requested in the SAPS Security Evaluation Report page 5 of 8.

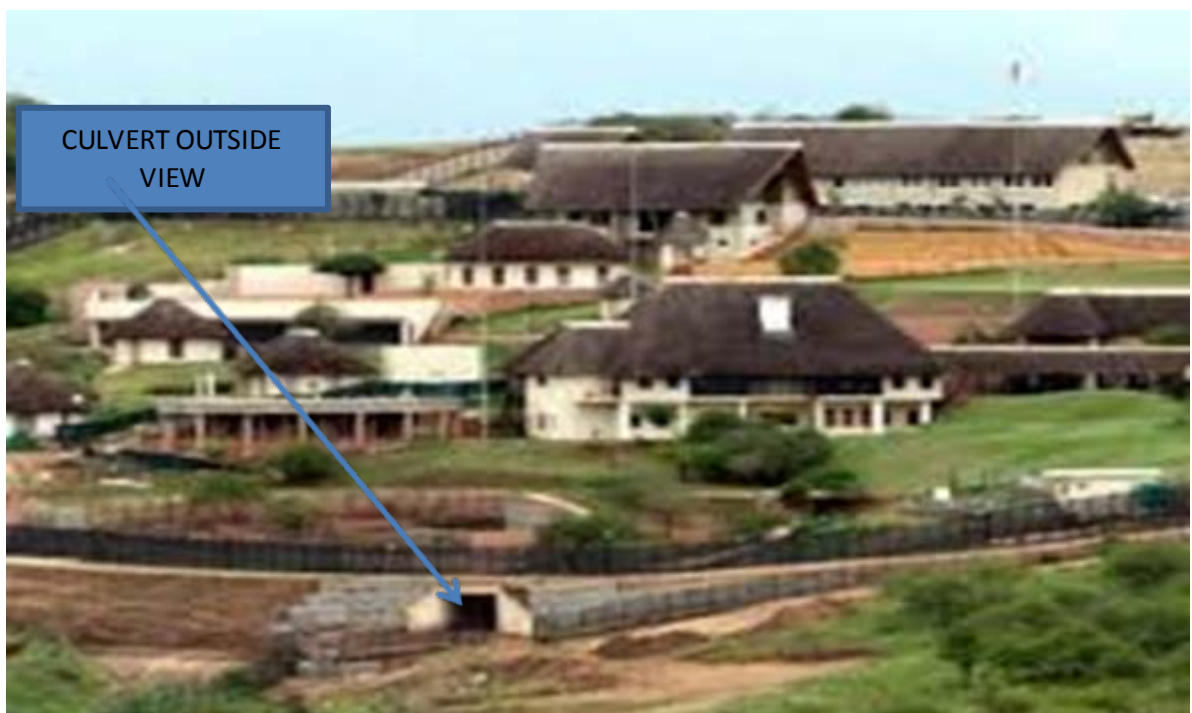
**Figure 8: The culvert**

6.3.3.4 This move was necessary because an interface between the inner or outer perimeter fence technology and animals or human beings would have triggered the alarm, which in turn would have registered as a violation of the security zone at the control centre. Therefore allowing animals to roam around would have triggered continuous false alarms and rendered the entire security system ineffective. The picture below shows the culvert underneath the outer PIDS perimeter fence.

6.3.4.1 The culvert channels the animals in and out of the new kraals and/or enclosure such that the outer perimeter security system (PIDS) as well as the inner perimeter's motion detection beams (MDB) is not interfered with, thereby avoiding interface and triggering false alarms.

6.3.4.2 A DPW Report dated June 2011 and titled "Motivations and cost allocation proposals no.4" provides the following motivation for the livestock culvert *"...Livestock access in and out of the homestead is provided via an under pass punching through the high security fence. A trafficable cattle culvert pass under the fence and there are gates at both ends of the culvert. This was a security design consideration which allow for continuous flow of the high security fence with less false alarm on motion detection..."*

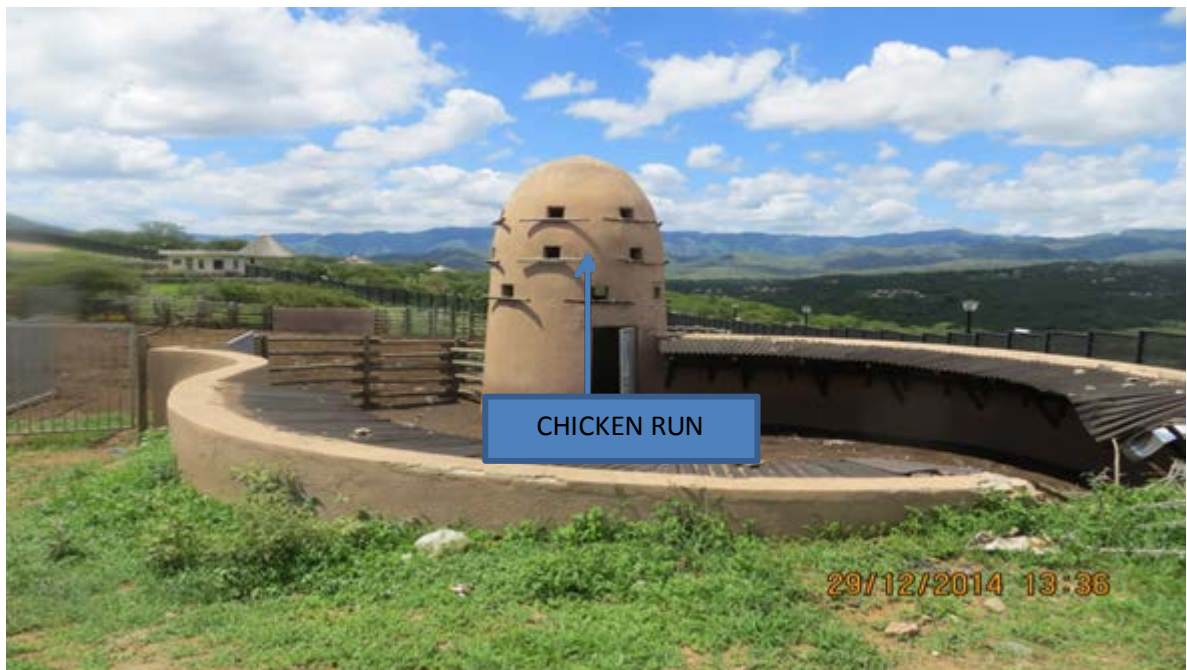
**Figure 9: The chicken run**

6.3.5.1 The sensors on the PIDS fence and motion detector beams (MDB) are very sensitive to the extent that they could easily be activated by free running chicken.

In this regard, free running chicken needed to be confined to a chicken run outside the high security zone and away from the Perimeter Intrusion Detection System (PIDS) fence technology.

6.3.5.2 Constant false alarms, possibly caused by animals or persons, result in a tendency by the security officers to either ignore any further alarms or simply switch off the system. It is for this reason that security practitioners recommended that the animals should be kept away from the outer and inner perimeter fence technology and be kept in the new enclosure with separate entrance and/or exit (culvert). ([Video security appraisal & culvert](#))

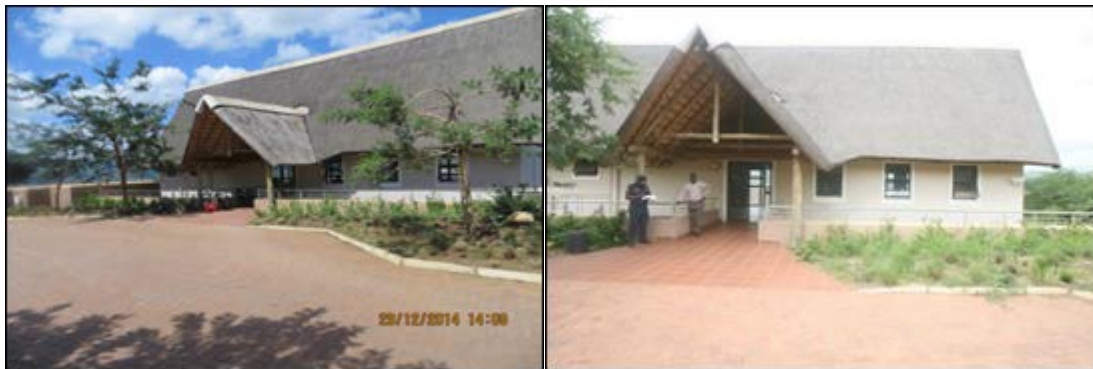
**Figure 10: Visitors' Center**

It should be noted that, according to the R&G Consultancy Report, the visitors' center and control room were requested by the SAPS. Further that the visitors' center on top of the SAPS control room.

6.4.1 The President of the Republic is also a Head of State in terms of the Constitution Chapter 5, section 83(a) and he continues to discharge his responsibilities even when at his residences. Such engagements include receiving and hosting Presidents from other Countries and high profile local and international guests.

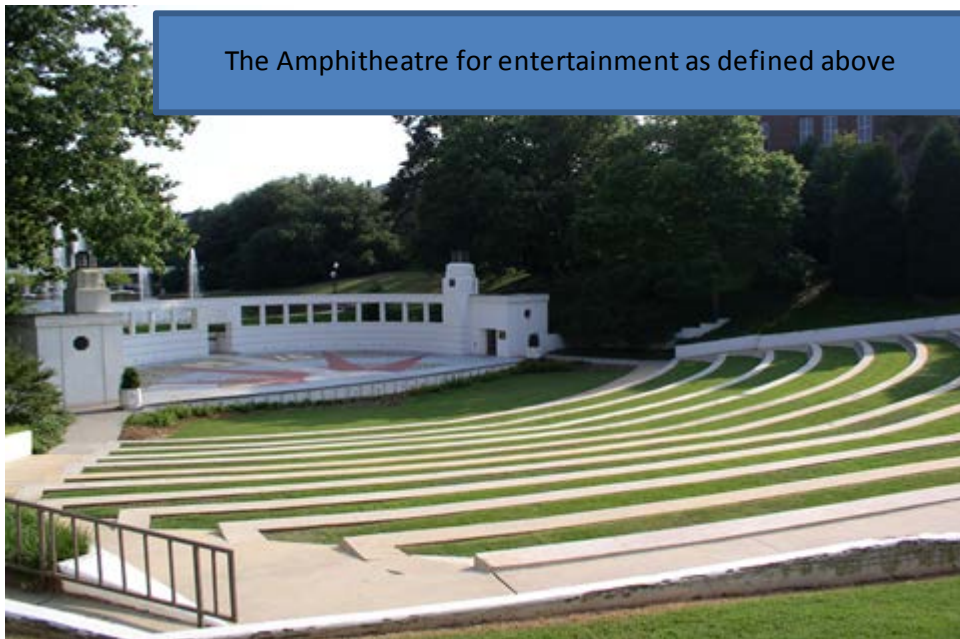
**Figure 11: Amphitheatre**

*The theatre would normally have electrical points to provide for entertainment or sound system in an appropriate stage.” ([www.wikipedia/amphitheatredefinition.com](http://www.wikipedia/amphitheatredefinition.com)). This has been so since the ancient Roman times.*

6.5.2 The Parliamentary Adhoc Committee observed that *“The land on which the President’s private residence has been developed lies at a gradient of 40 to 70 degrees which makes it more susceptible to flooding during storms. Due to the gradient, all construction activities such as earthworks and landscaping had to include fortifications, buttresses and paving for proper water flow and storm water drainage.”*(Parliamentary Ad Hoc Committee, 2014:2963, para 3.32 and 3.33).

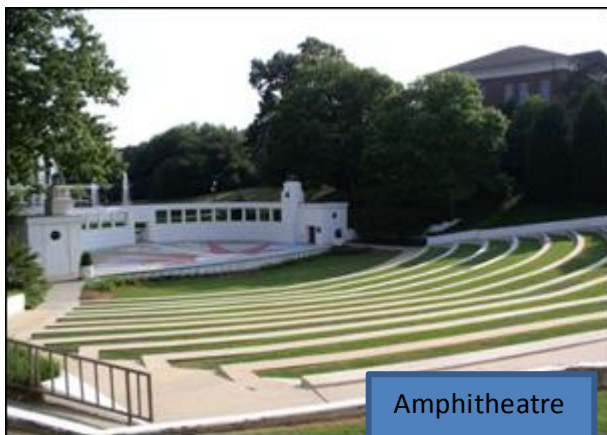
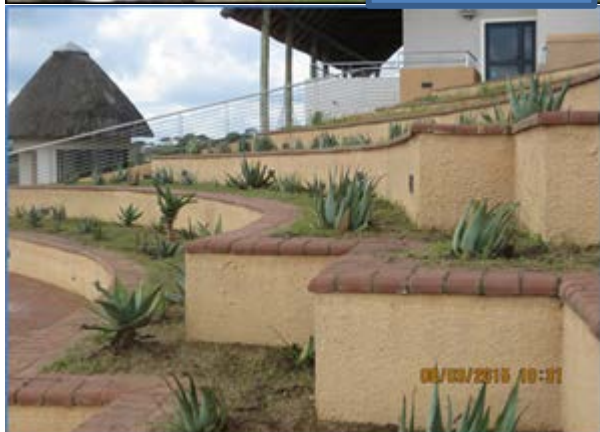
**Figure 12: Amphitheatre vs the President's homestead**

6.5.4 Below are pictures of what is referred to as an amphitheatre. The picture on the left is an amphitheatre designed for entertainment purposes. The picture on the right is what has been referred to as an amphitheatre at the President's residence in Nkandla. The civil engineering reports make reference to both an amphitheatre and a soil retention wall. Clearly the picture on the right does not resemble an entertainment area.

Social definition: An open air venue used for entertainment, performances, and sports

Architectural definition: Soil retention design with large grass steps so that it looks like an amphitheatre

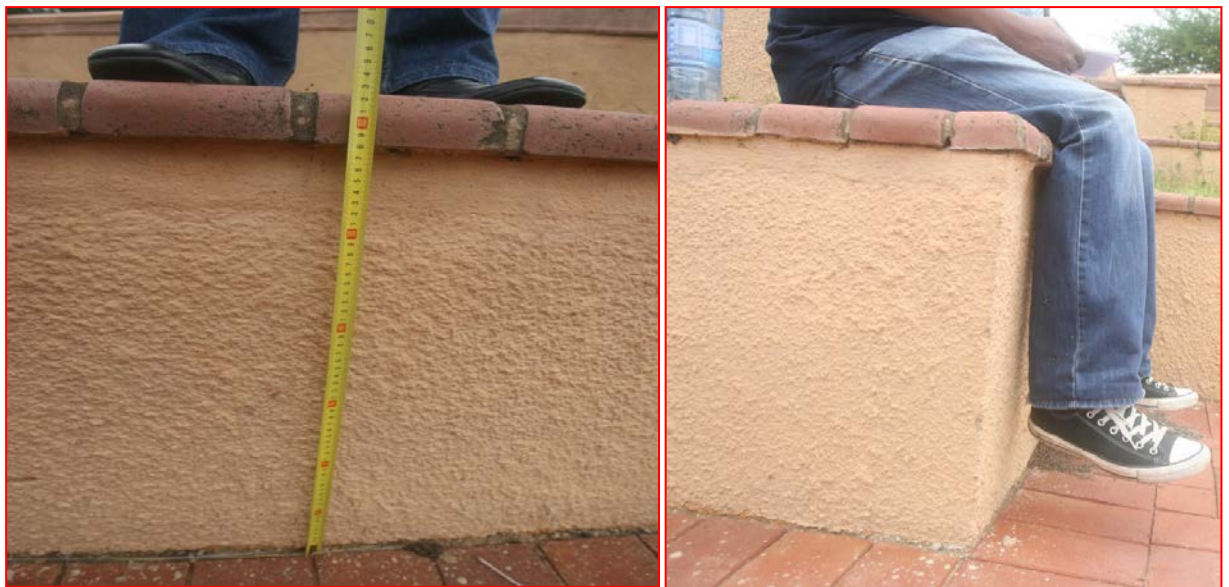
**Figure 13: Walls not built for sitting**

6.5.10 The height of the step is 0.65 meters whereas the horizontal platform or width is between 0.7m to 1.3meters. With illumination on the vertical walls, whereas if it was to be used as amphitheater there would have been people seated and obscuring the illumination. It would be unimaginable that people would be seated in an aloe garden with irrigation system; this could not be regarded as amphitheater under the circumstances.

6.5.11 The dwarf stepping soil retention walls are the best in terms of safety and security in that it avoids obscurity of the view of security persons and does not provide hide out for would be intruders. The dwarf stepping walls are preferred in terms of strength and safety as opposed to steep sloping single soil retention walls that pose danger to persons falling and breaking bones or falling to their death.

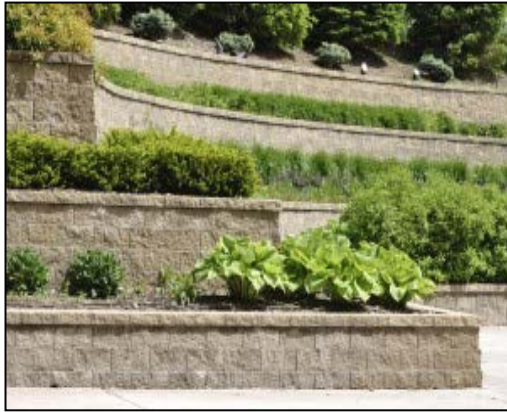
**Figure 14: Stepping stone retention walls**

6.5.12 The pictures below are regarded by landscape experts as the best and sustainable method of soil retention *“Retaining walls prevent soil and substrate from moving because of erosion or gravitational pull”* <http://www.soilretentionmethods.za>. These are also regarded in landscaping terms as Dwarf Wall Sloping Terrace.

6.5.13 The stepping up ground retention methods shown above are recommended as the best method, also regarded as stronger than single wall retention, single retention walls tend to curve in and crack due to geological and storm water pressure. The R&G Engineers Report stated under the heading 'Landscaping' on page 21 that, *"....retaining walls were required due to the new security access road infrastructure ...."*

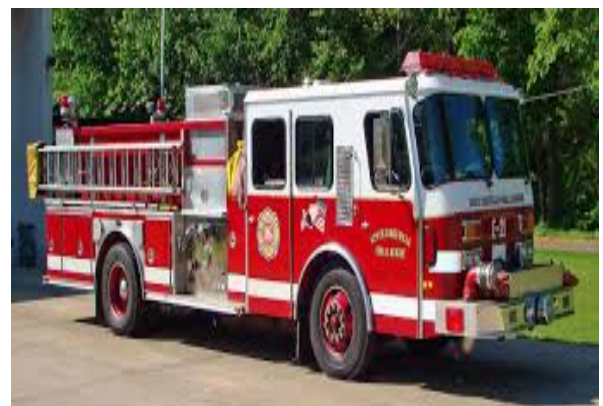
**Figure 15: Heavy duty vehicles**

6.5.14 The retention wall at the private residence of the President in Nkandla had to be strong and stepping in order to retain ground that carries the main homestead internal road. The positioning of dwarf walls sloping terrace assist in retaining the soil which carries the upper road surface. The upper road is used by heavy duty vehicles as illustrated below. This includes heavy fire fighting trucks, armored personnel carrier, SAPS Nyala armored personnel carrier and VIP vehicles.

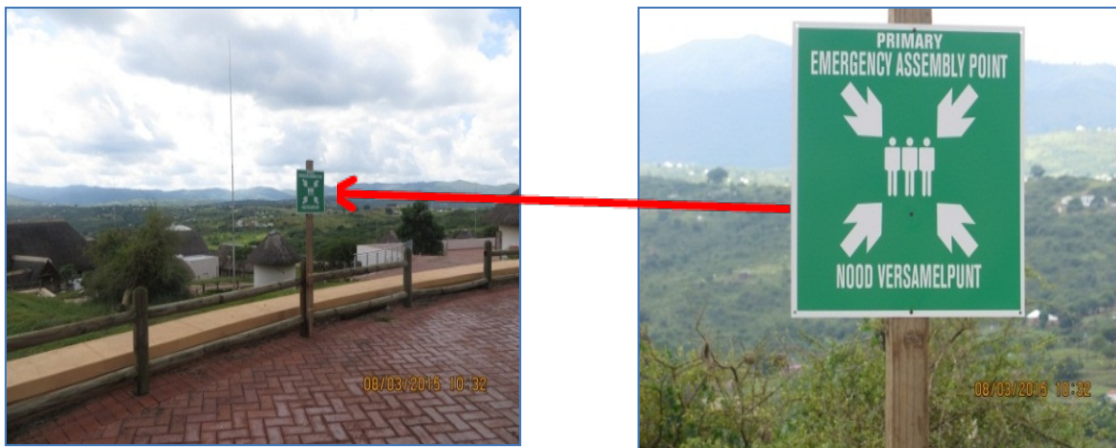
**Figure 16: Emergency assembly point**

6.6.2 In case of major security emergencies, security drills and demonstrations by law enforcement officers; as well as emergency services would be able to assemble for briefing and debriefing at this particular zone.

6.6.3 The homestead is occupied by a number of people as well as the family members of the President. In case of any fire threats, bomb threat or medical emergencies the occupants of the homestead would assemble at this particular area referred to as “amphitheatre”. This area has appropriate signage and thus provides illumination linked to the electrical mains, as well as the backup generators. The linkage of this area to the back-up generator is in line with the SAPS Security Evaluation Report, page 7 of 8 which states

6.6.4 The existence of the assembly area complies with the Occupational Health and Safety Regulation which requires that any dwelling occupied or used for office or accommodation by a number of people should have such an area in order to take stock of the occupants and their conditions during emergency. ([video amphitheatre](#))
